Addressing Polycom Trio 8500 'Choppy Audio'

This technical advisory addresses an issue impacting the audio quality of some Trio 8500 conference phones. This issue impacts Trio 8500 systems shipped from Poly prior to May 20, 2019.

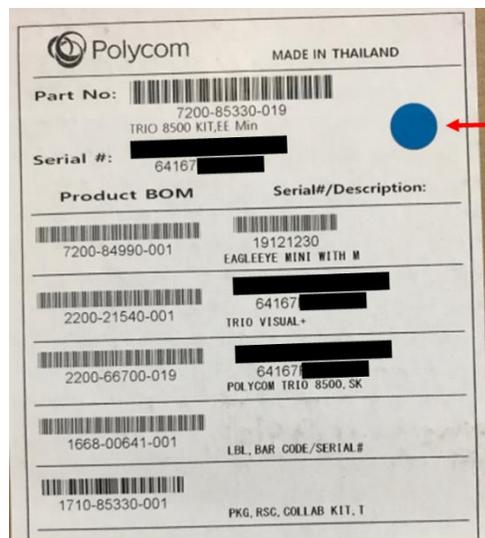
Trio 8500 system shipped from a Poly warehouse on or after May 20, 2019 have been marked with a **BLUE** or **BLACK** round circle dot sticker on the shipping box label. See examples below.

Blue or black round circle dot sticker

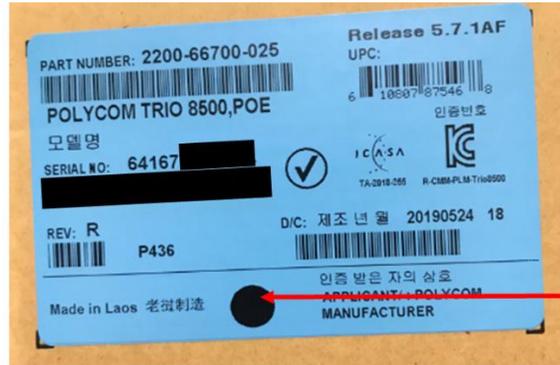
Blue or black round circle dot sticker
