## Poly Trio 8300 LCD Faint Vertical Lines

This technical advisory is a notification of an issue impacting the LCD of some Trio 8300 and Trio 8300 NR (no radio) conference phones. This issue impacts Trio 8300 and Trio 8300 NR systems manufactured in 2019.

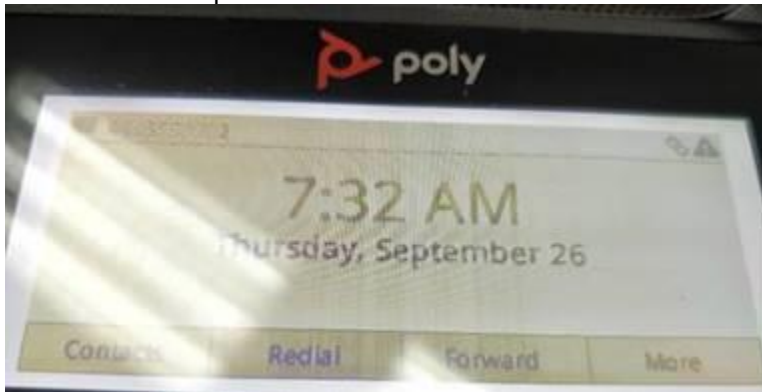
The issue is presented to a Trio 8300/Trio 8300 NR users as faint vertical lines on the phones display at some display contrast levels. The issue may not be observed at lower display contrast levels.

Please reference picture below:

- **WORKAROUND:** From the Trio 8300/Trio 8300 phone menu Settings > Basic > Contrast adjust the contrast level until the faint vertical lines disappear.
- **Recommended Solution:** Upgrade the Trio 8300/8300 NR systems affected to Poly Trio Software 5.9.2 Rev AA that will be released later in December 2019 to accept a display driver optimization that will correct the appearance of faint vertical lines on the Trio 8300 LCD.
