Polycom® CX5100 and CX5500 Unified Conference Stations for Microsoft® Lync®

Polycom announces the release of version 1.1.1 software for the Polycom CX5100 and CX5500 Unified Conference Stations for Microsoft Lync. This document provides the latest information about the Polycom CX5100 and CX5500 systems.

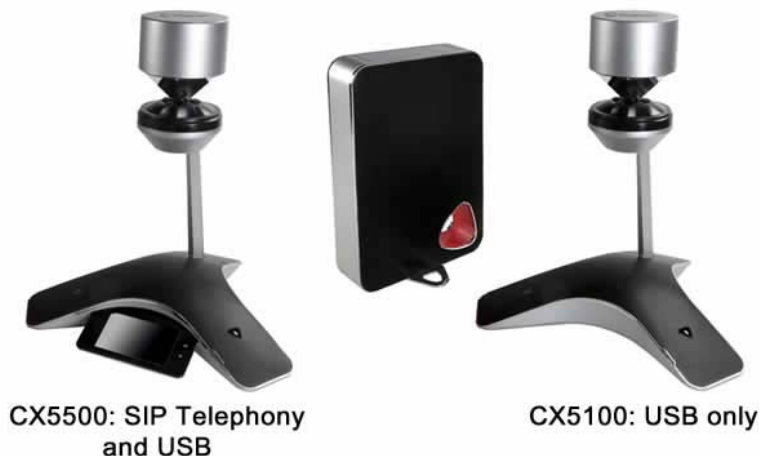
The Polycom CX5100 and CX5500 Unified Conference Stations enable you to use the collaboration capabilities of Microsoft Lync voice, video, and content while automatically tracking the flow of conversation to support richer, more interactive communication. The following figure shows the CX5500 tabletop unit with LCD panel, the CX5100 tabletop unit, and the power data box for both systems.

Polycom CX5500 and CX5100 Unified Conference Systems
