Polycom® RealPresence Debut™

Introducing Polycom® RealPresence Debut™

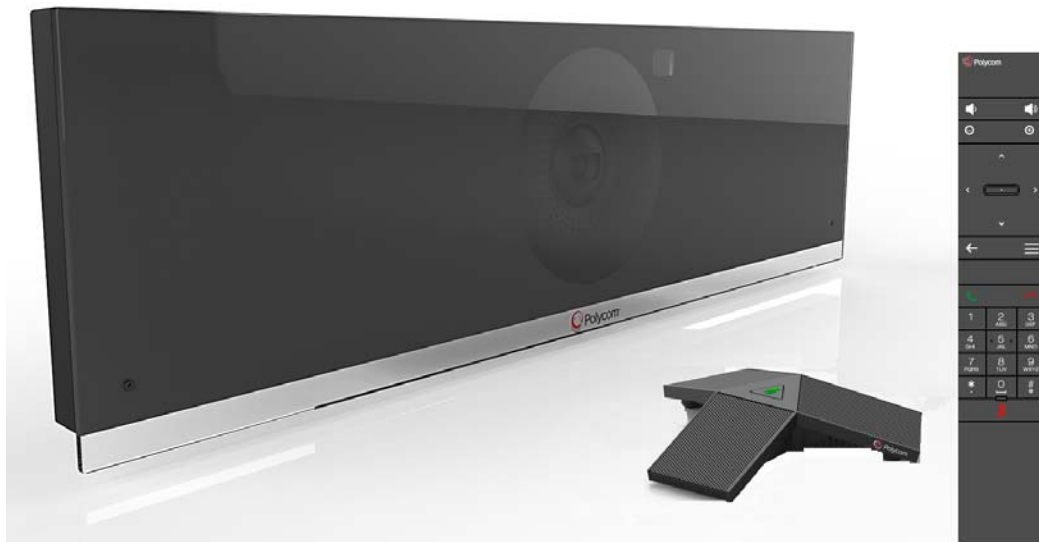
The Polycom RealPresence Debut™ system is an all-in-one micro-codec video endpoint. The system is designed for use in enterprise environments that require a high-quality video and collaboration tool that is easy to deploy and use in huddle rooms and small conference areas.
