# Release Notes

Polycom HDX Systems, Version 2.0.1

Polycom is pleased to announce the release of version 2.0.1 software for Polycom® HDX systems. This document provides the latest information about the Polycom HDX systems and version 2.0.1 software.

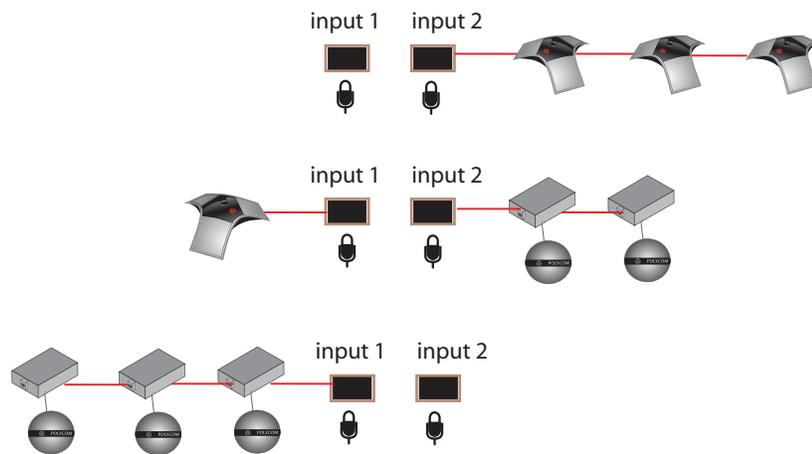
- Up to three Polycom HDX digital microphones or ceiling microphones with a Polycom HDX 4000 or HDX 8000 HD system.
- Up to four Polycom HDX digital microphones or ceiling microphones with a Polycom HDX 9000 series system.
- A SoundStructure C-Series digital mixer, in addition to other microphones.

The following figure shows several connection examples.

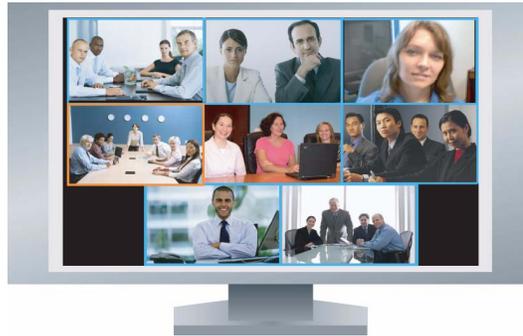
In HD multipoint calls using Discussion display mode, up to eight sites can be displayed at the same time. In Discussion mode, the current speaker is highlighted with an orange border, as shown in the following illustration.
