# Polycom<sup>®</sup> RealPresence<sup>®</sup> Group Series

Polycom announces a new release of Polycom® RealPresence® Group Series software. This document provides the latest information about the following Polycom software:

- Version 4.3.1 of the Polycom RealPresence Group system software
- Version 2.2 of the Polycom® EagleEye™ Director software
- Version 1.0.1 of the Polycom® EagleEye™ Producer
- Version 4.3.1 of the Polycom Touch Control Operating System software
- Version 4.3.1 of the Polycom Touch Control Panel software

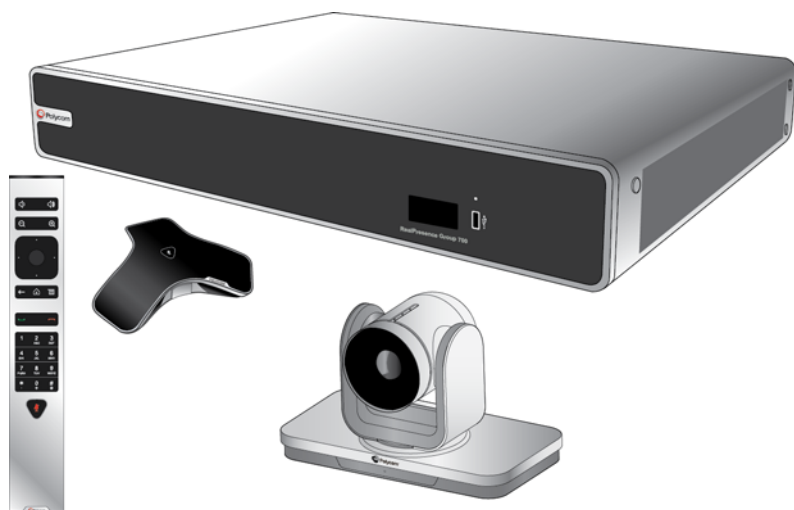
### Polycom RealPresence Group 700 system and accessories

RealPresence Group 700 systems ship with a Polycom EagleEye IV camera, a Polycom RealPresence Group Microphone Array, and a Polycom RealPresence Group Remote Control.
